DEPARTMENT OF NATURAL RESOURCES

Division of Oil, Gas and Mining
JOHN R. BAZA
Division Director

Minerals Inspection Report

Mine Name: Peat Humas	Permit Number: S/023/0058	Mine Status: Inactive
Operator Name: Bonnie Birch Jensen	Inspection Date: 03/31/2014	Permit Fees: Delinquent
Inspector(s): Wayne Western	Inspection Time: 5:00 - 5:30 pm	Bond Amount: \$0
Attendee(s): none	Weather: cold cloudy	Bond Escalation:
Inspection Purpose: Follow up from enforcement		Prior Inspection: 08/14/2013

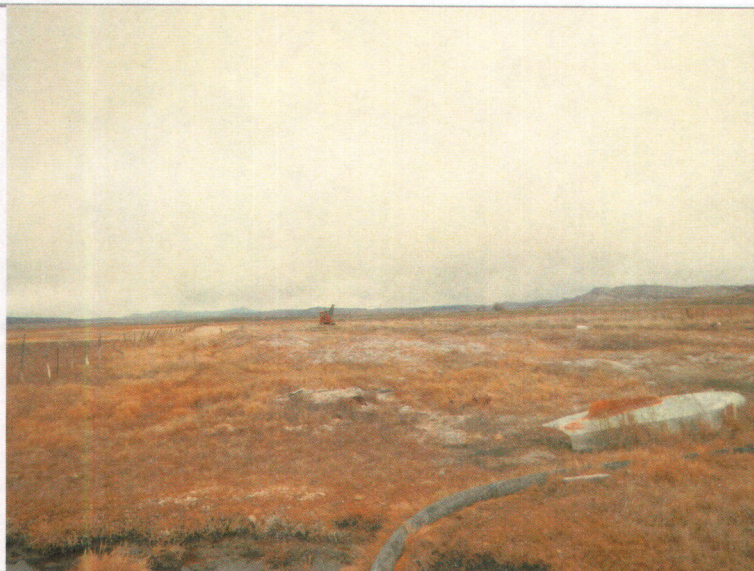
Drag line still on site and other debris

The Operator failed to reclaim the site. The Division should take action to remove that equipment on site and prevent damage to the environment.

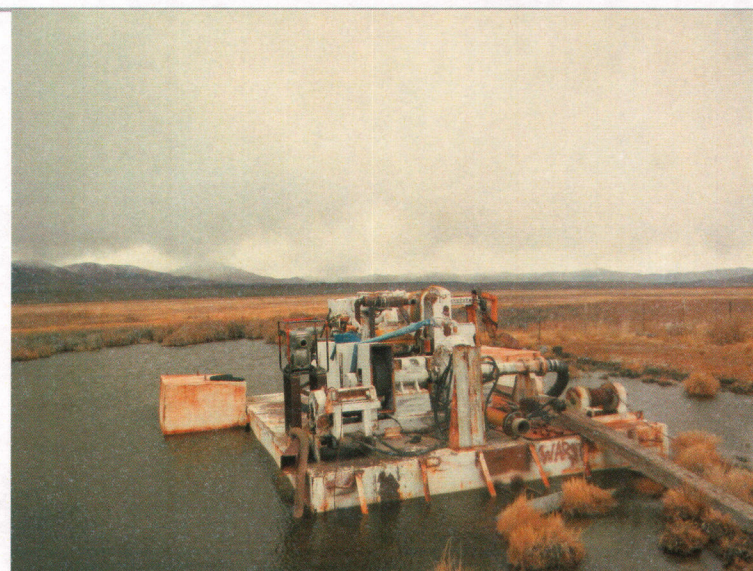
4.	Deleterious Material	<input checked="" type="checkbox"/>	<input checked="" type="checkbox"/>
Barge is still in the water and poses a potential risk to the environment. Tanks and other equipment are on shore.

Barge is still in the water

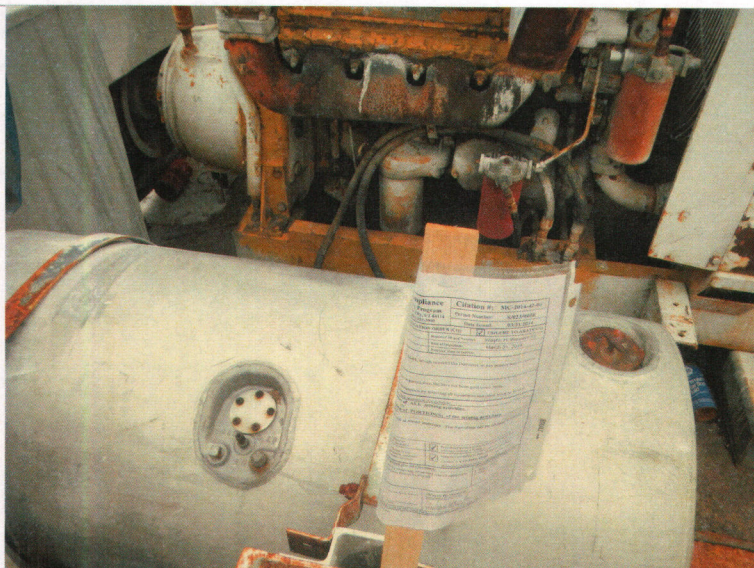
Elements of Inspection		Evaluated & Commented	Enforcement
1.	Permits, Revisions, Transfer, Bonds	<input checked="" type="checkbox"/>	<input checked="" type="checkbox"/>
Documented that the site has not been reclaimed. Barge is still in the water and tanks are on shore. Posted an FTACO-2014042-04 on site. Operator failed to pay permit fees, post adequate bond and/or reclaim the site.

FTACO posted on site

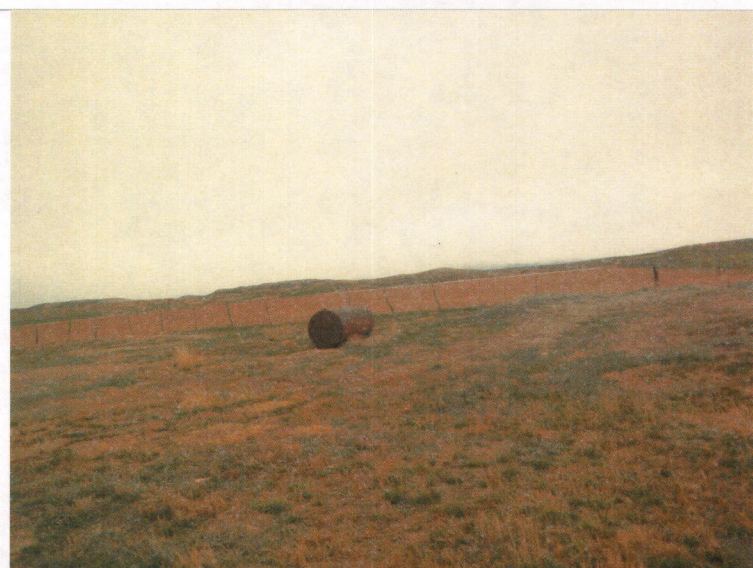
Fuel tank on shore
